Service life cycle example

Case Study

Services spanning from predictive maintenance to up-tower repairs

Moventas high-qualified technicians and engineers can perform up-tower repairs even on non-Moventas gearboxes. Moventas team in Italy has recently completed successfully an up-tower repair on a 2 MW wind turbine. The work included the replacement of intermediate shaft (IMS) assembly and high-speed shaft rotor side bearing (HSS RS).

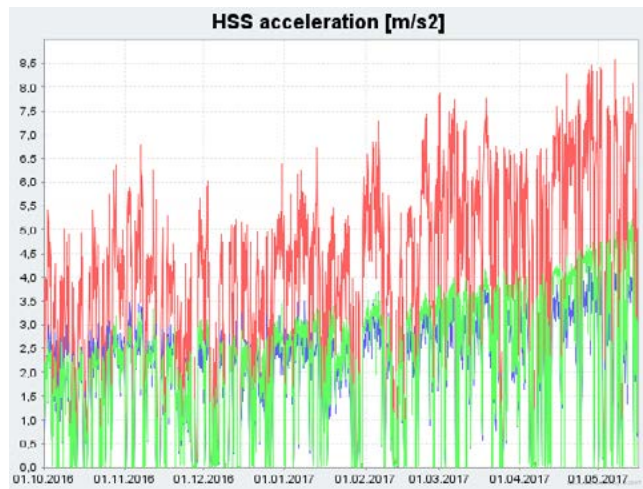
Figure 1

The defects were initially detected by our remote Condition Management System – CMaS, which keeps a watchful eye on seven key parameters: temperature, vibration, load, pressure, RPM, oil condition and oil particles. Thanks to CMaS, it was possible to prepare the maintenance activity largely in advance, minimizing the downtime of the turbine and preventing further failures of the gearbox components. CMaS showed an increasing of the overall parameters, such as the acceleration values (figure 1 and 2) and the cumulative oil particles (figure 3).

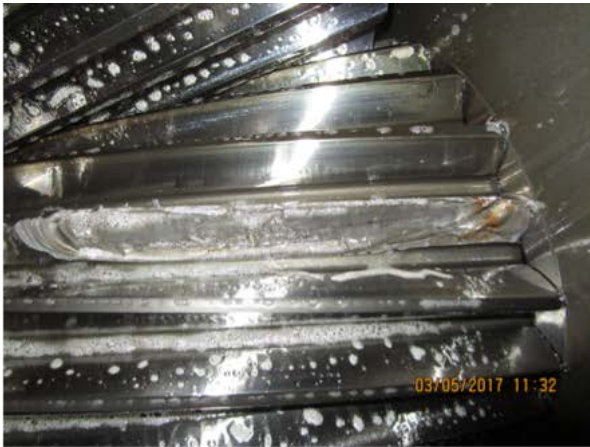
The endoscopic inspection confirmed the results of the vibration analysis. A broken tooth was detected on the IMS pinion and the HSS RS bearing was found in bad condition. Widespread indentations were detected on the outer race, as well as initial spalling. Rolling elements were affected by polishing. Unfortunately, the inner race could not have been inspected.

Picture 1
Broken tooth of IMS pinion.

Following the vibration analysis and the endoscopic inspection, Moventas technicians performed the replacement of IMS assembly and HSS RS bearing.

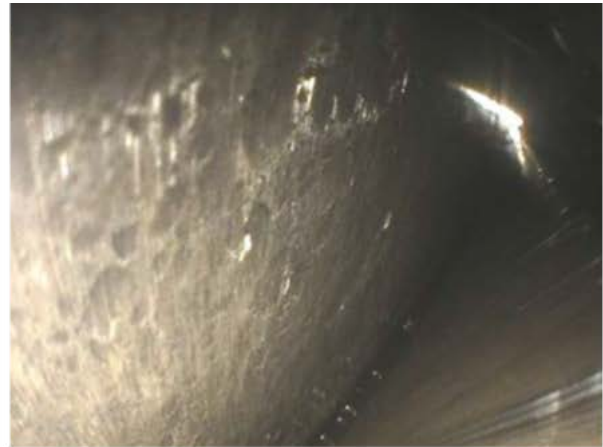
Picture 2
Bad condition of HSS RS bearing outer race and rolling elements.

Moventas has developed special tools for replacing the HSS RS bearing without extracting the entire high-speed shaft, which saved time and reduced the costs.

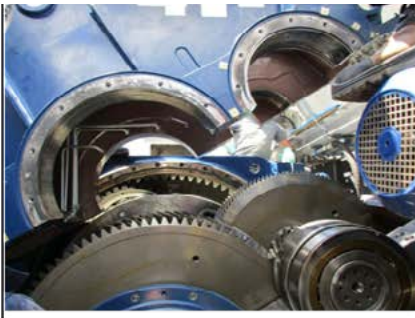
Picture 4.
Housing opening.

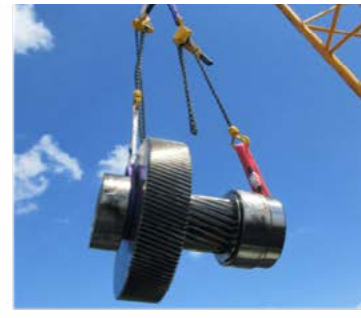
Picture 6.
Damaged IMS removal.

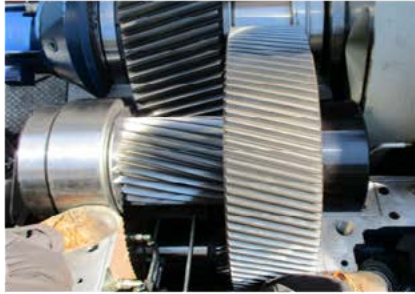
Picture 7.
New IMS installed.

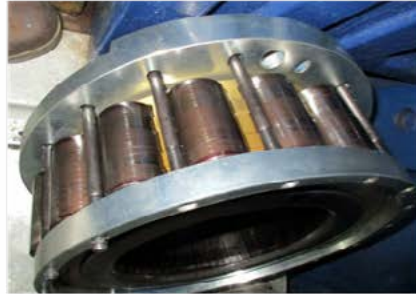
Picture 5.
Damaged HSS RS bearing.
